NASA Contractor Report 166065

Flight Service Evaluation of Kevlar-49 Epoxy Composite Panels in Wide-bodied Commercial Transport Aircraft

Ninth Annual Flight Service Report

LOCKHEED-CALIFORNIA COMPANY
BURBANK, CALIFORNIA

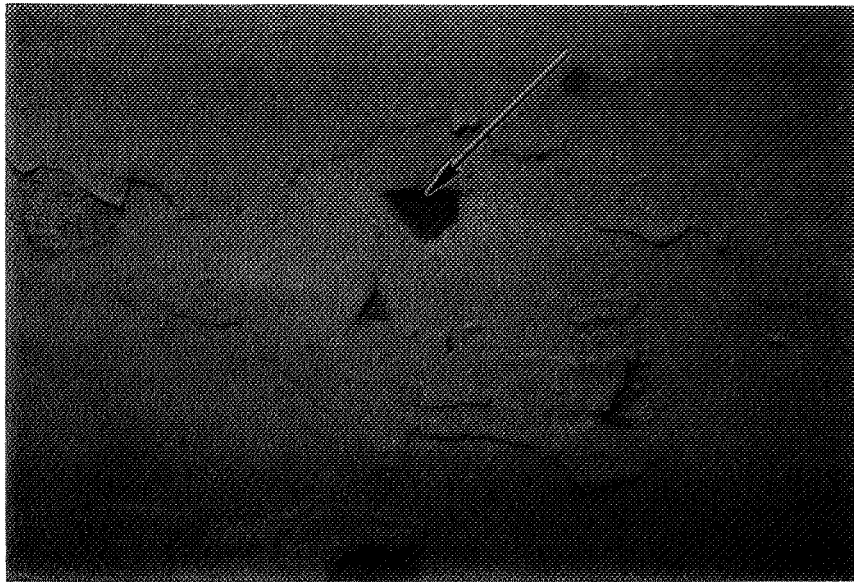
1. A deep gouge in the upper center area of the panel exterior, 0.4 by 0.6 cm (5/32 by 1/4 in.), had not changed in size or appearance since the previous inspection (figure A-1). This was first observed in 1978.

Figure A-1. - Air Canada left-hand wing-body fairing -
deep gouge on exterior.

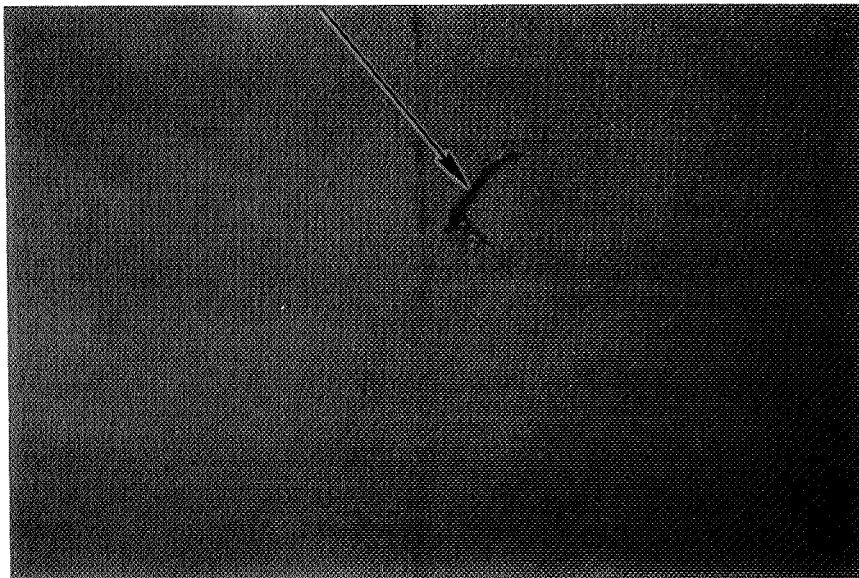
4. Two cracks on the inner surface had not changed in size or appearance since the previous inspection of the inner skin in 1980. One was a 0.8 cm (5/16 in.) crack in the upper forward area first observed in 1978; and the other was a 1.3 cm (1/2 in.) crack first observed in 1980 (figure A-2).

Figure A-2. - Air Canada left-hand wing-body
fairing - 1.3 cm (1/2 in.)
crack on inner skin.

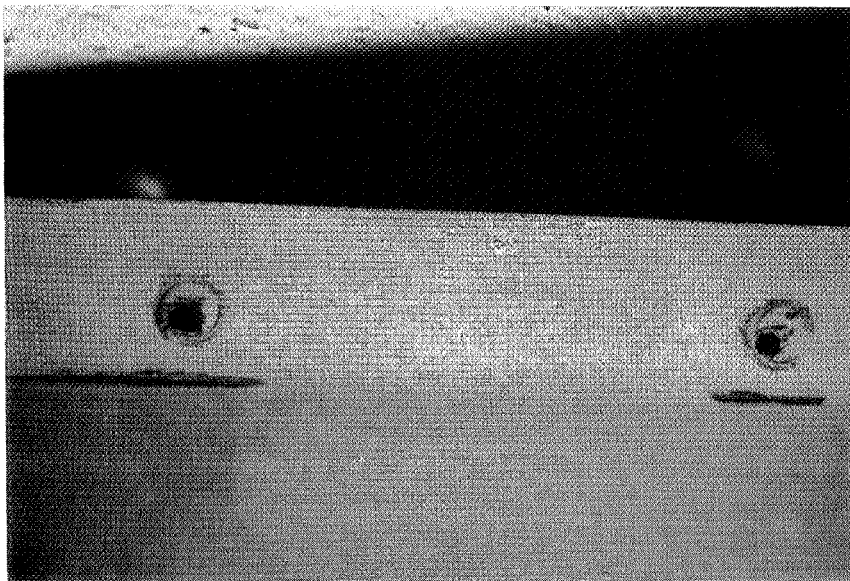
6. Slight fraying was observed on all fastener holes, with a greater degree of fraying noted on the aft and lower edges. Slight elongation

was noted on several holes on the upper, aft, and lower edges. These included five holes elongated to 0.55 cm (7/32 in.) from the original 0.5 cm (3/16 in.) dimension, and four holes elongated to 0.6 cm (1/4 in.). The holes on the lower edge had the greatest degree of fraying along with a distinct fastener mark-off (figure A-3). These conditions have not changed significantly since the previous inspections.

Figure A-3. - Air Canada left-hand wing-body fairing - frayed holes on lower edge with mark-off.

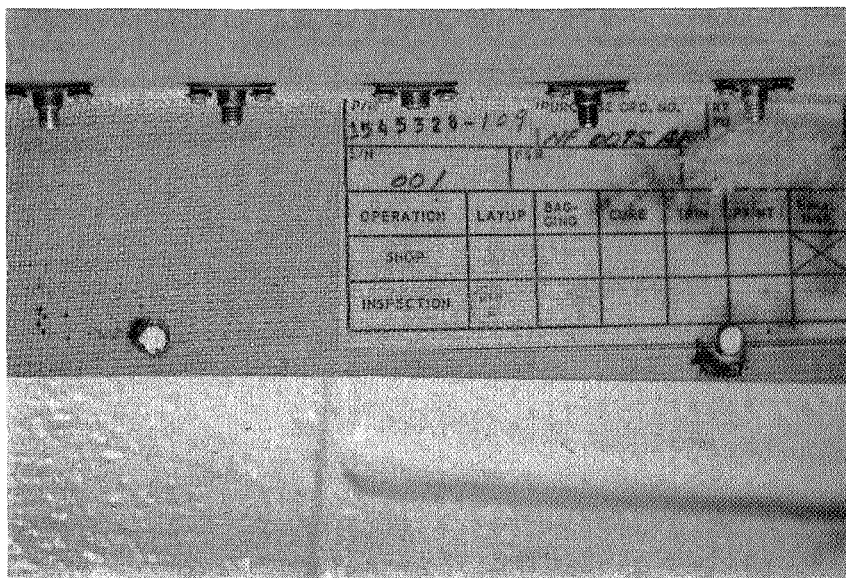
Figure A-4. - Air Canada left-hand underwing fillet - frayed and elongated fastener holes.

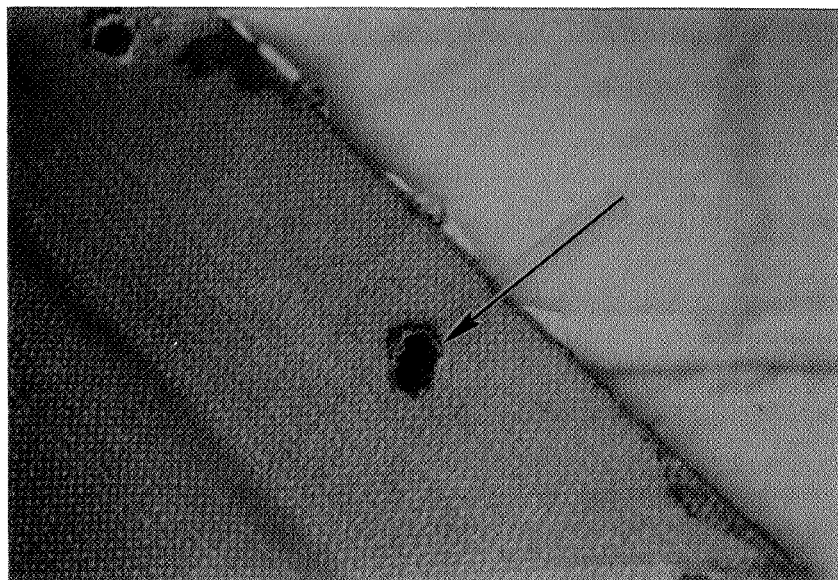
4. Several holes had a slight amount of elongation. Three holes were elongated to 0.55 cm (7/32 in.) from the original 0.5 cm (3/16 in.) diameter, and one hole was noted to be a double hole with a maximum 0.7 cm (9/32 in.) dimension (figure A-6). This was out of approximately 110 fastener holes on the aft engine fairing, so the incidence of hole elongation was very minor.

Figure A-6. - Air Canada right-hand aft engine fairing - badly elongated hole.

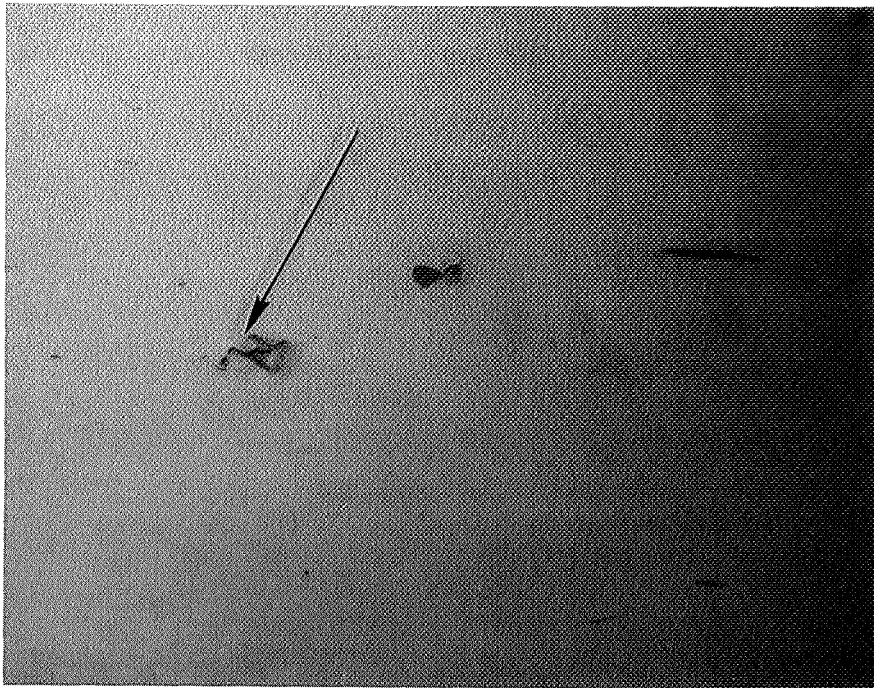
1. Two cracks were observed on the exterior surface: a deep gouge in the upper aft area first noted in 1981 (figure B-1), and a small 0.3 cm (1/8 in.) crack in the same area which was also first noted in 1981. The deep gouge was measured at 0.8 cm (5/16 in.) length with delamination extending about 0.3 cm (1/8 in.) beyond the crack. Repainting made visual comparisons with the 1981 inspection difficult.

Figure B-1. - TWA right-hand wing-body fairing,
gouge on exterior surface.

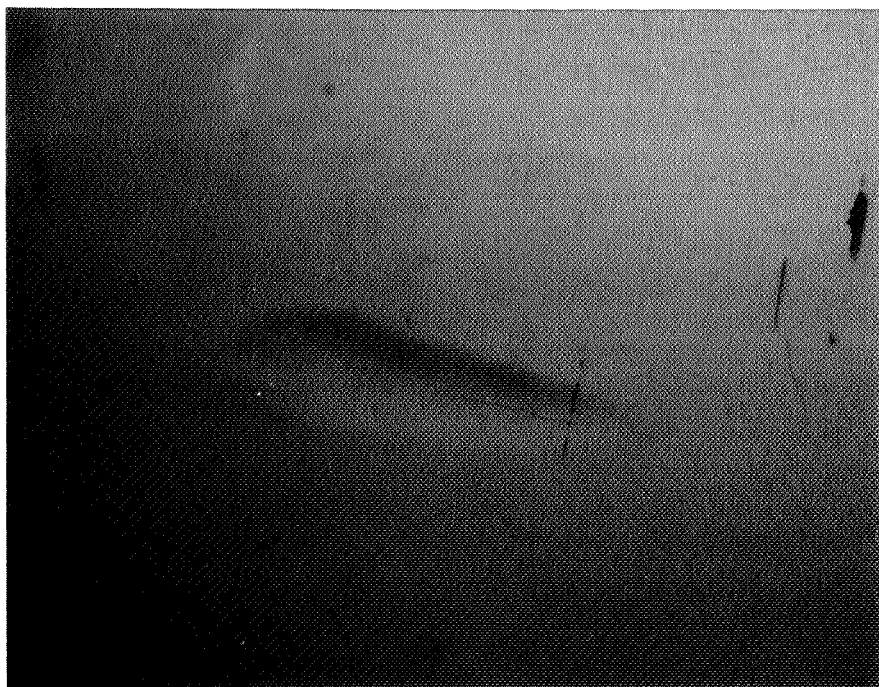
2. Two other small cracks observed in previous inspections were not detected indicating they had been only in the paint.
3. A large teardrop shaped disbonded and crushed area, 11.4 by 2.5 cm (4-1/2 by 1 in.) had not changed in size or appearance since the previous inspection (figure B-2). This was first observed in 1977, and is in the lower forward area of the exterior surface at the probable location of a repair. A small depressed area in the lower forward area of the exterior surface, first observed in 1978, had not changed since the previous inspection. These may represent areas where some force has caused core crushing without skin penetration, and in the smaller area without a skin-core disbond.

Figure B-2. - TWA right-hand wing-body fairing -
disbonded and crushed area.

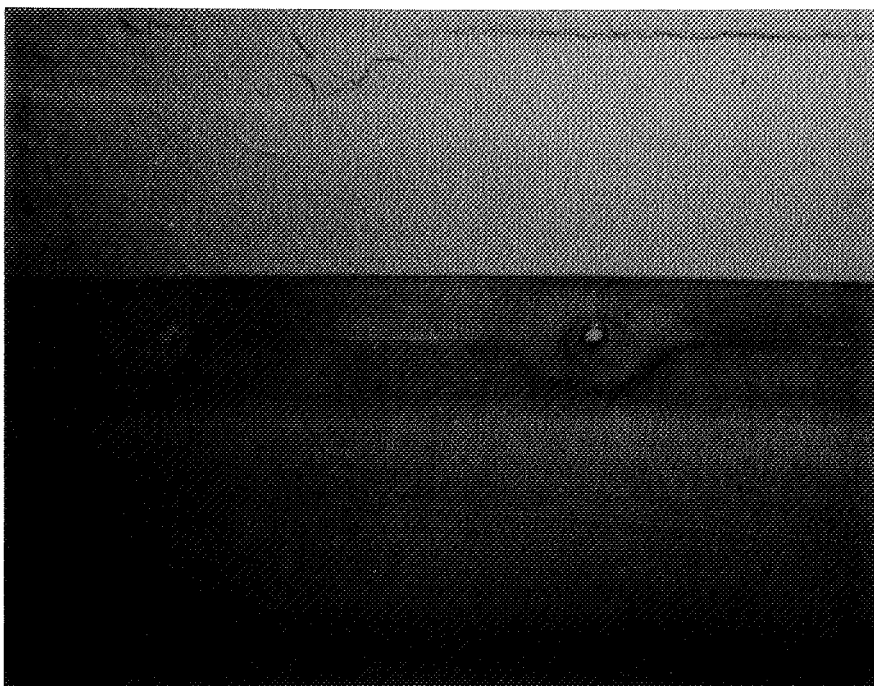
7. Fraying was observed on most of the fastener holes to a slight degree (figure B-3). Fraying was more pronounced on the lower edge, and the five aft holes on the lower edge were very badly frayed.

Figure B-3. - TWA right-hand wing-body fairing -
typical slight fraying of
fastener holes.

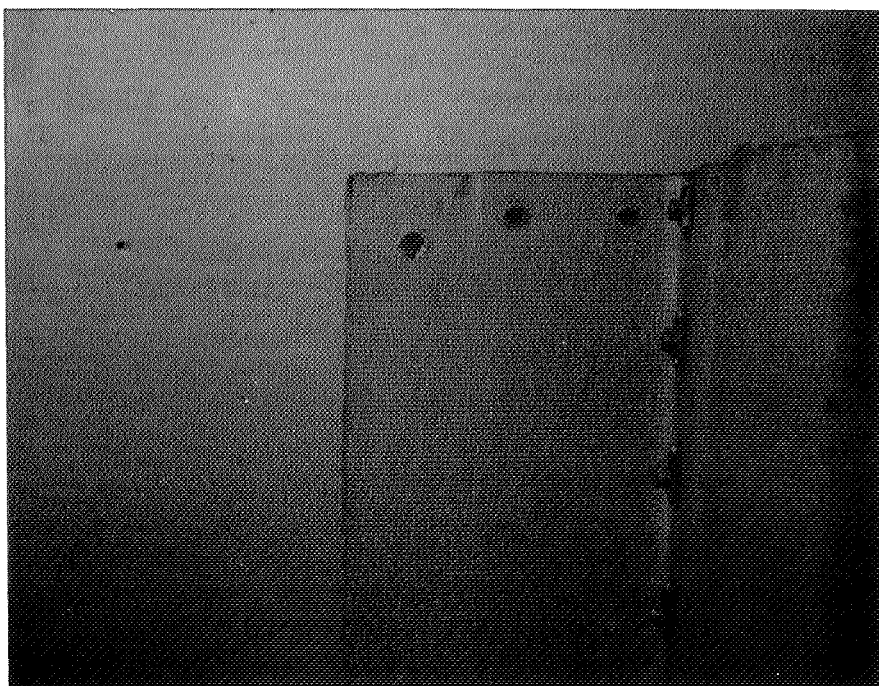
Figure B-4. - TWA right-hand underwing fillet -
frayed fastener holes.

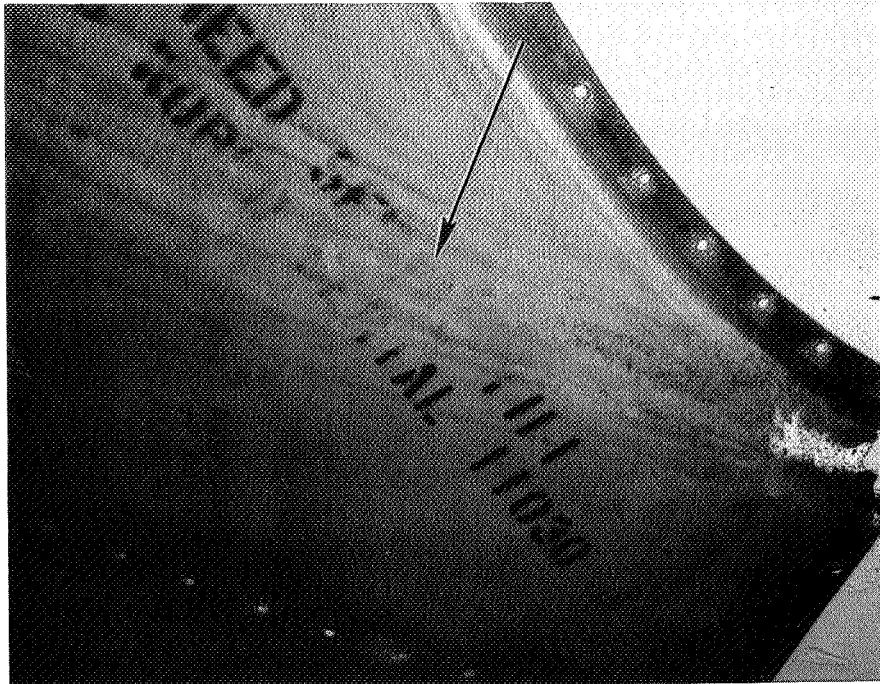
2. There was considerable degradation of the vapor barrier coating on the inner surface by Skydrol, particularly in the aft area (figure B-5).
3. The fastener holes showed very little fraying. All of the fastener holes were redrilled when this part was reinstalled (reference 2), and the drilling was performed after curing an outer layer of 120 fiberglass over both Kevlar-49 surfaces. The glass completely prevents the typical frayed condition of Kevlar-49 fastener holes.

Figure B-5. - TWA left-hand aft engine fairing -
Skydrol attack on vapor barrier

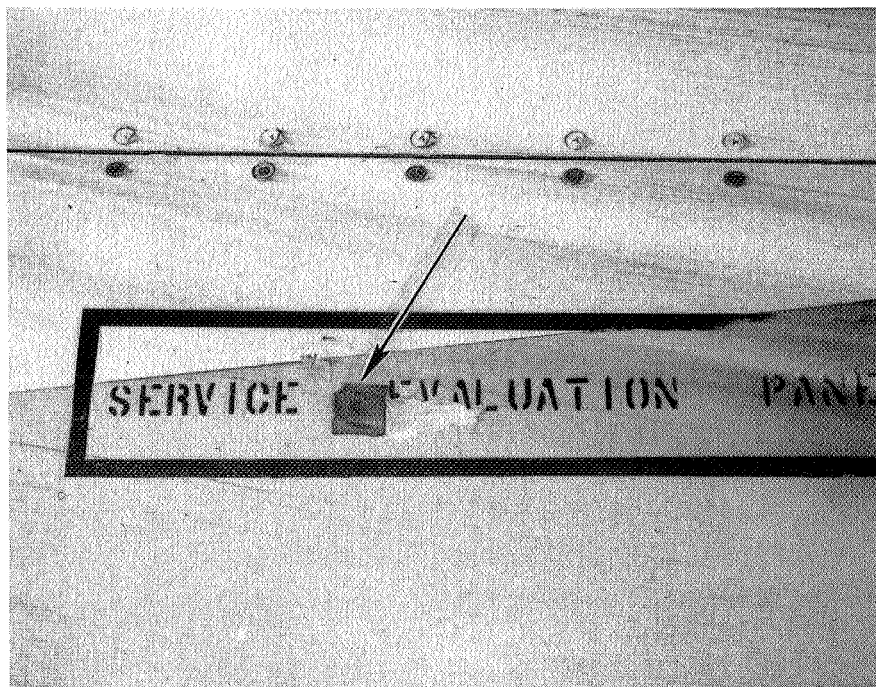
1. A tape patch repair of a deep gouge, first observed in 1980, was still in place with no changes in appearance since the previous inspection (figure B-6). There was some paint loss near the patch, but no delamination or evidence of damage growth.
2. Another repair, also observed in 1980, in which a 0.3 cm (1/8 in.) crack was filled with resin, was undetectable after repainting.
3. Two other cracks and an associated delamination were no longer detectable after repainting. These conditions were therefore only the result of loose paint.
4. An area of extensive paint loss along the forward edge was still present even though the panel had been repainted since the previous inspection. This indicates possible Skydrol exposure.

Figure B-6. - TWA left-hand wing-body fairing -
tape patch repair.

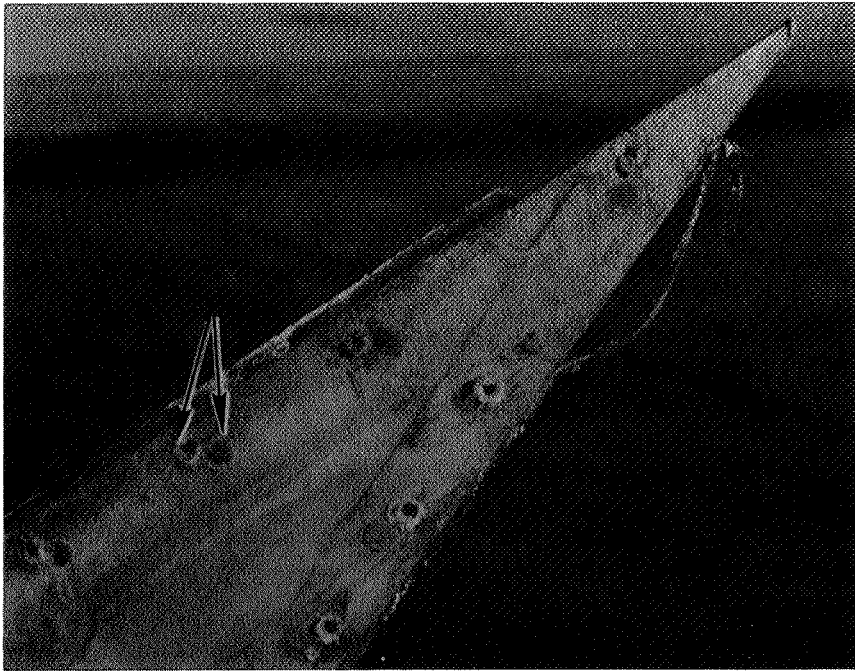
Figure C-3. - Eastern right-hand aft engine fairing - badly frayed holes after re-installation; filler in original holes.

3. A significant degree of elongation was observed in about 1/5 of the holes, principally at locations where the hole was drilled through the filler (which is chopped glass fiber filled epoxy) (figure C-4). Eleven holes were elongated to a maximum 0.55 cm (7/32 in.) dimension from the original 0.5 cm (3/16 in.); twelve holes were elongated to 0.6 cm (1/4 in.); and one hole was elongated very badly to 0.8 cm (5/16 in.).

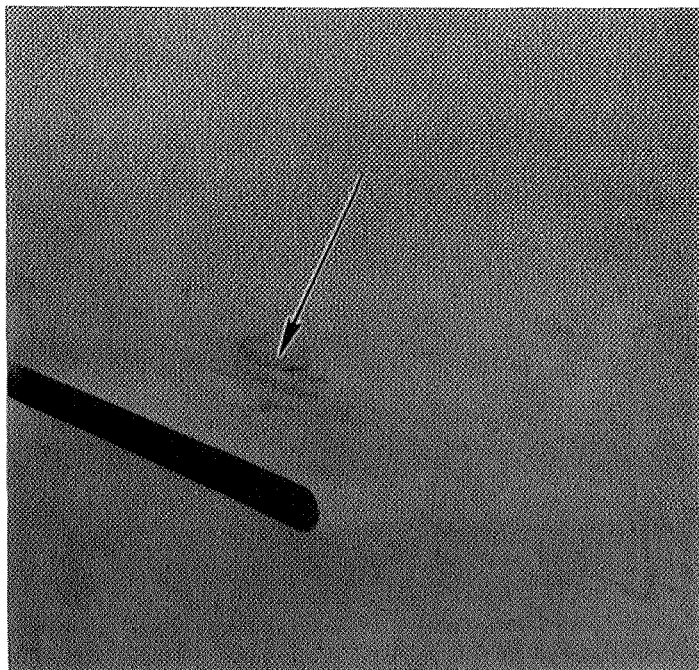
Figure C-1. - Eastern right-hand wing-body fairing - crack 2.5 cm (1 in.) long on inner surface.

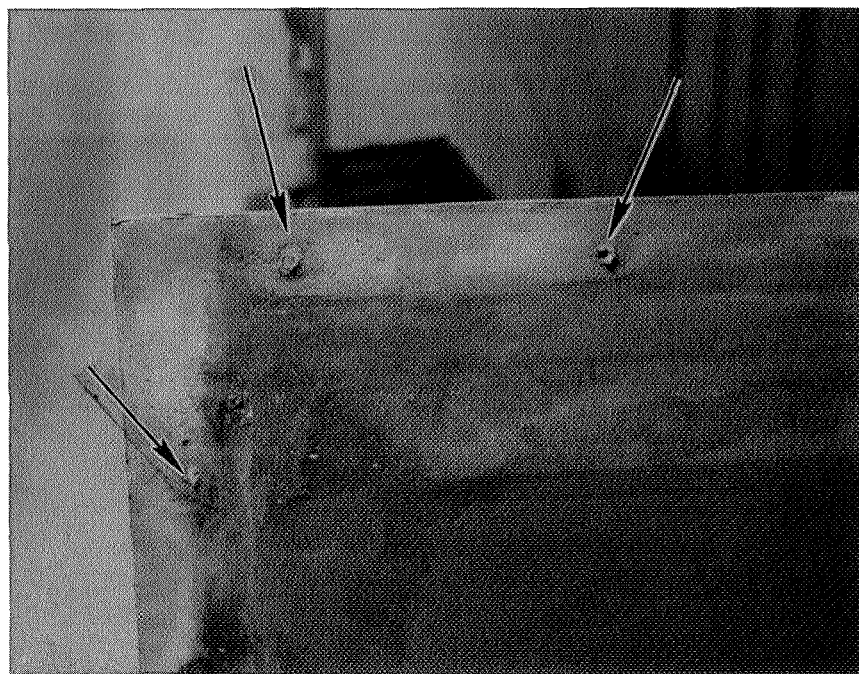
Figure C-2. - Eastern right-hand wing-body fairing - badly frayed holes.
